INSPECTION REPORT

CRYSTAL LAKE DAM CT DEEP #08301

PROUT HILL ROAD
PROUT BROOK
MIDDLETOWN, CONNECTICUT

FEBRUARY 2017

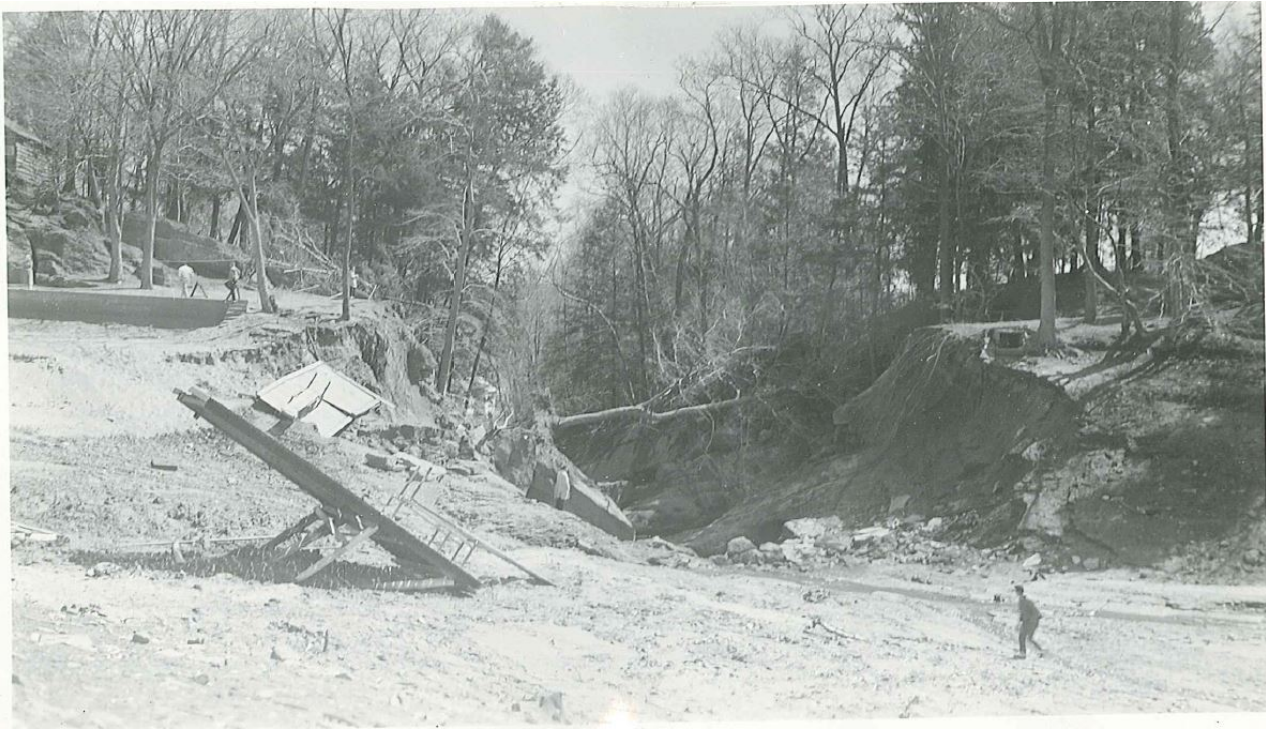
Photo taken May 3, 1961, looking downstream from within the empty lake toward the breached Crystal Lake Dam. The tree-covered bluffs on either side of the breach present a similar appearance as is present today.

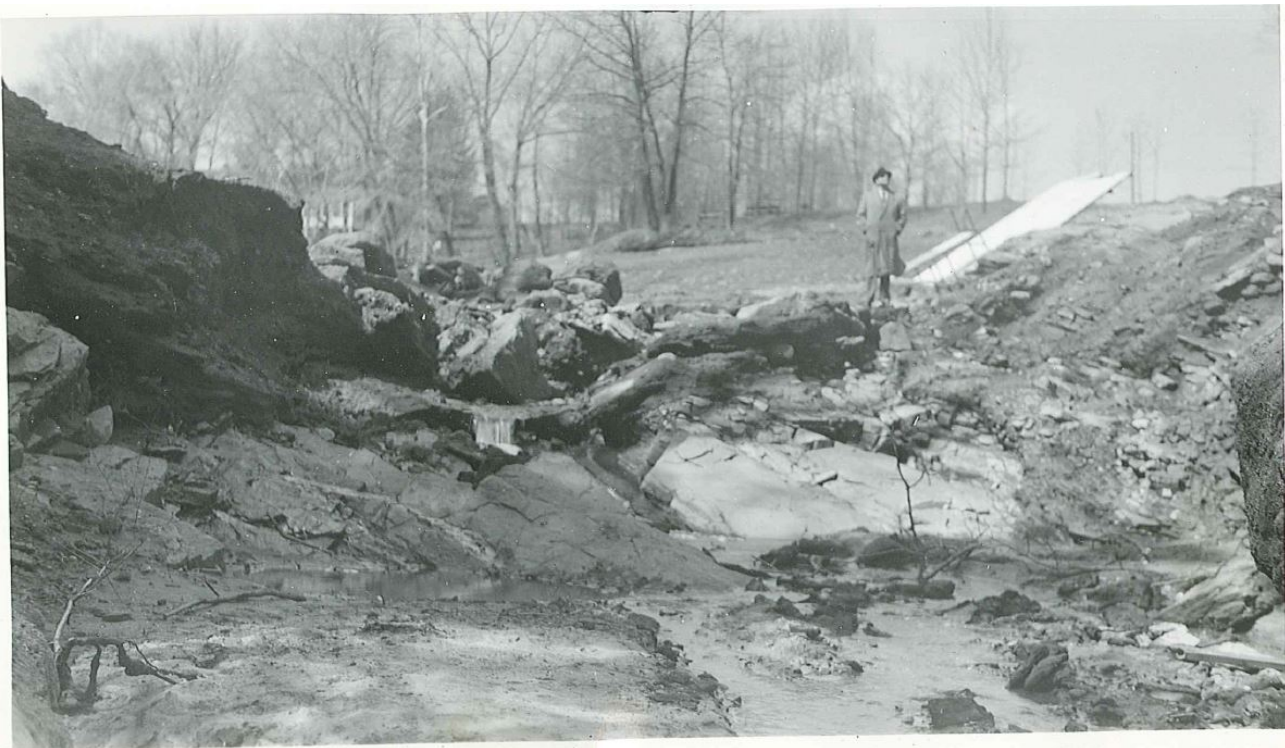
Another photo taken May 3, 1961, this time looking upstream at the area where the dam had previously stood.

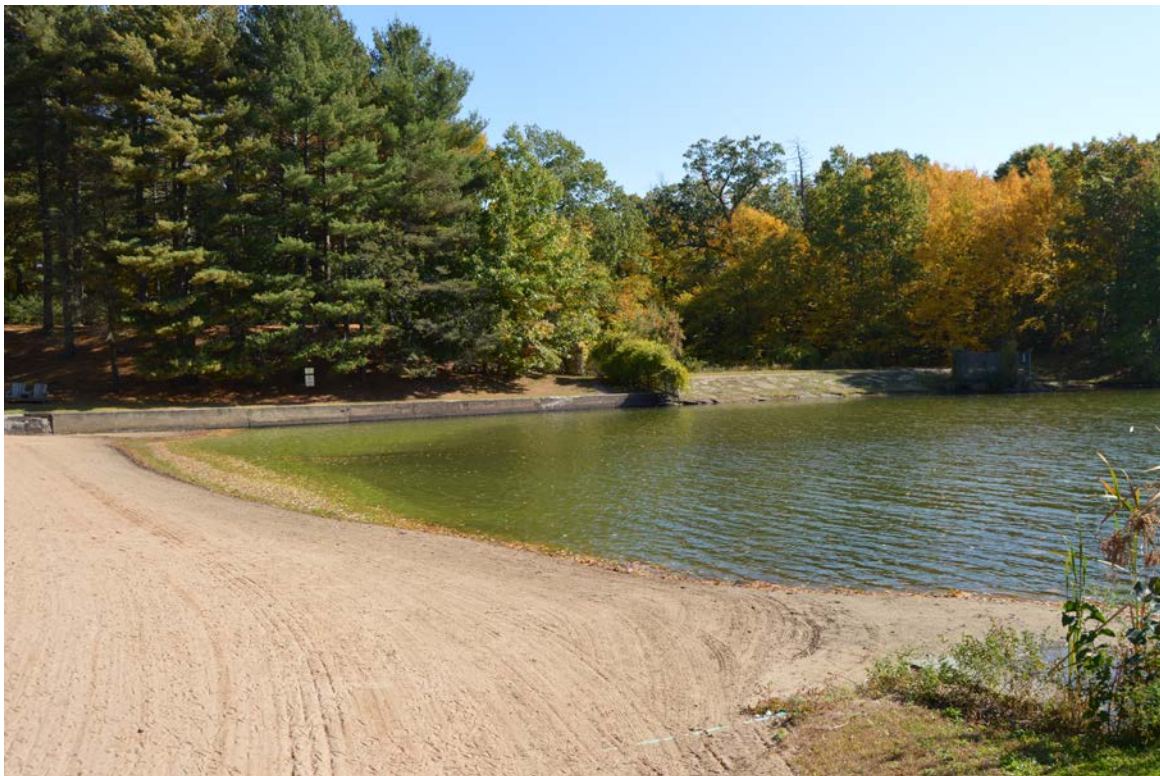
Photo 1a – An overview of Crystal Lake Dam, as seen from near the northwest corner of the impoundment.

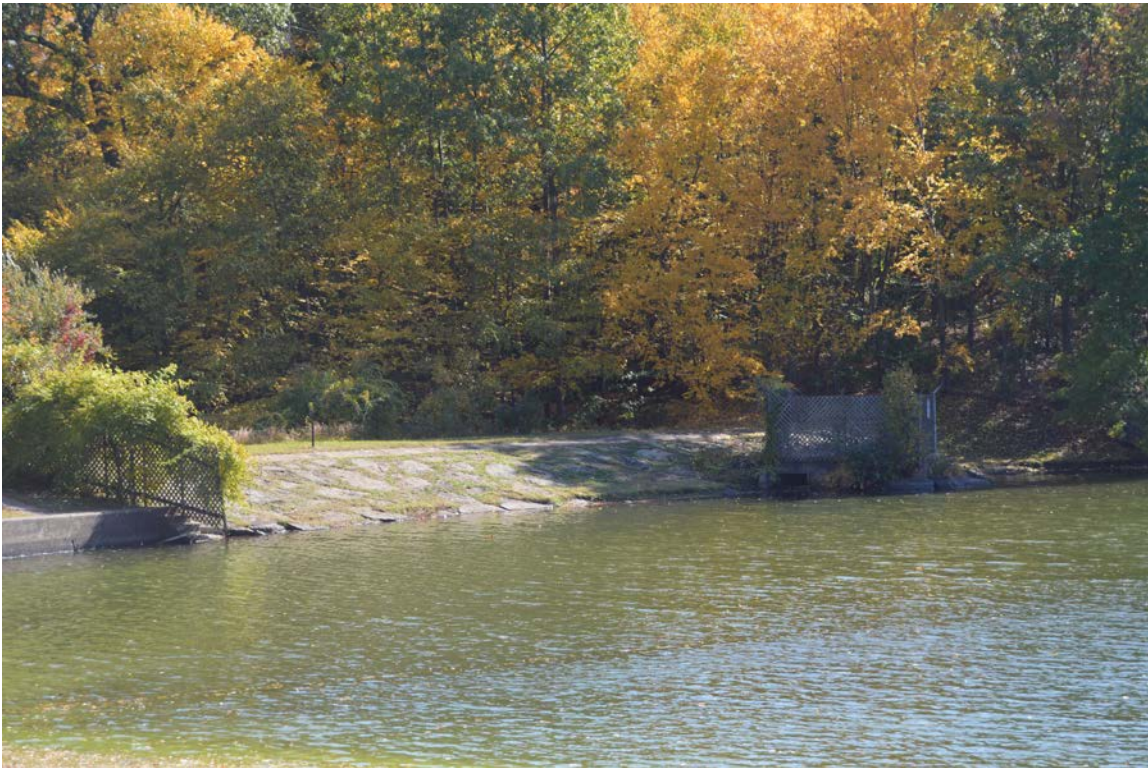
Photo 1b – An upstream view of the dam proper, taken from the same perspective as the prior photo.

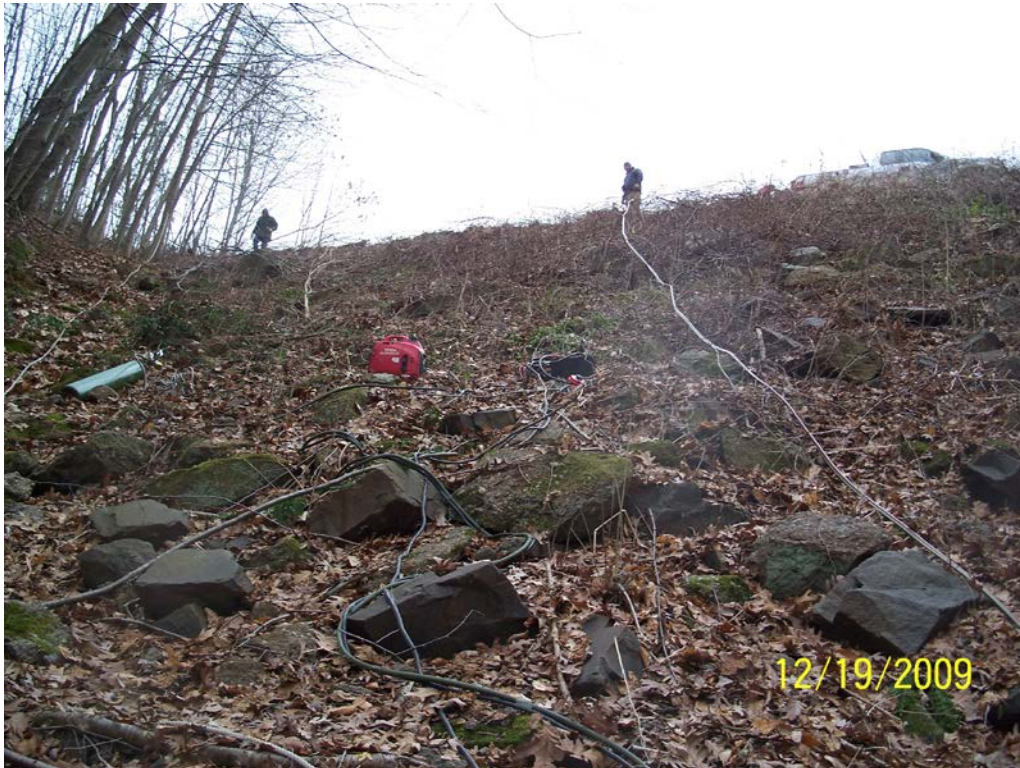
Photo 2b – Taken in December 2009, this photo shows an overview of the downstream embankment with brush and vegetation cleared.

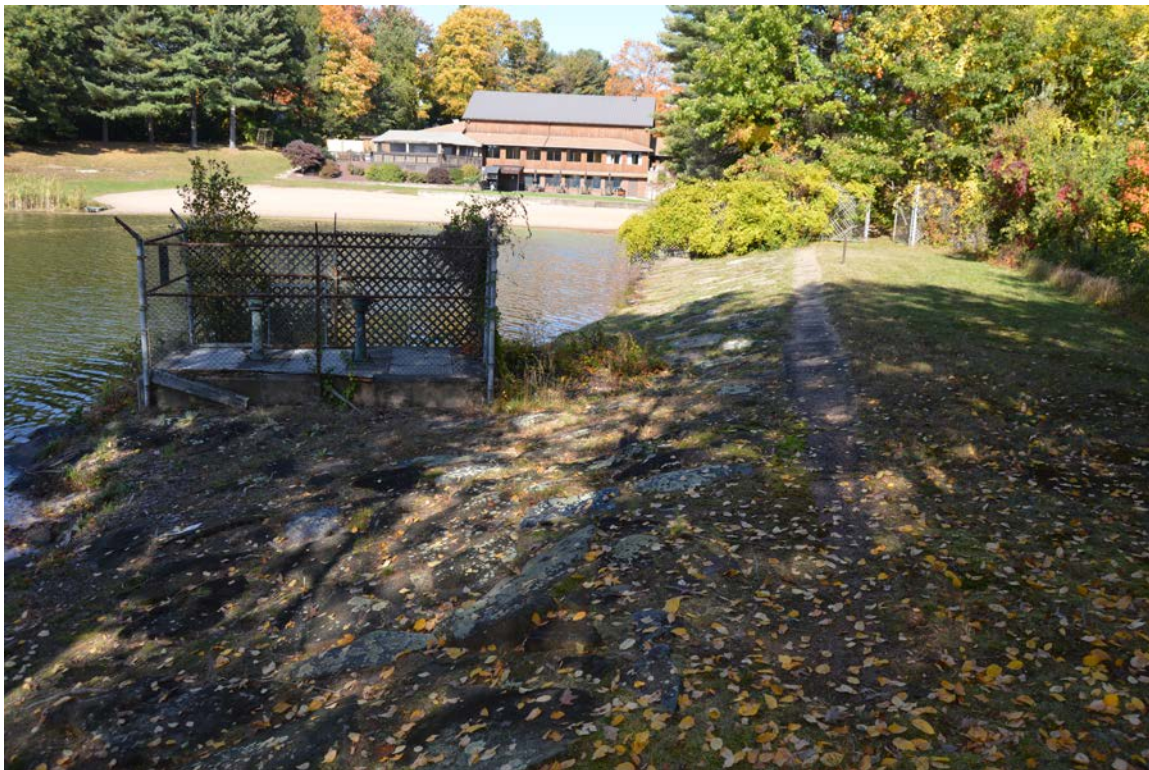
Photo 3a – The left and center areas of the upstream embankment as seen from the right side abutment.

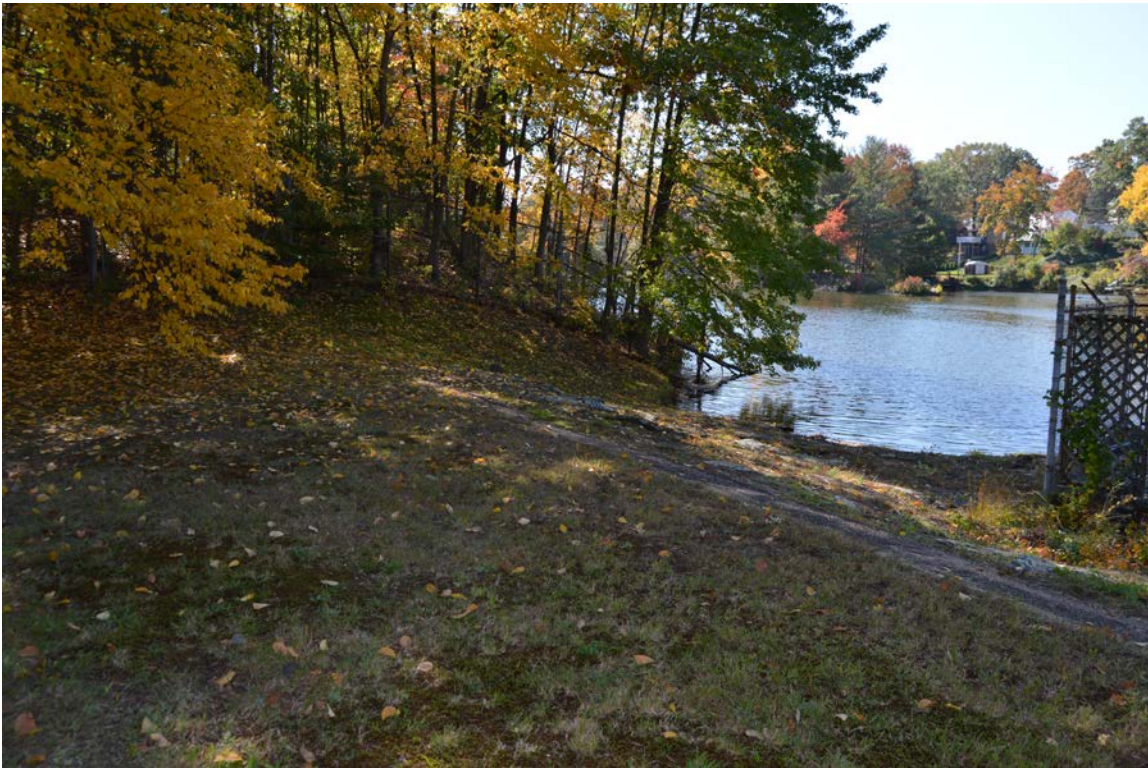
Photo 3b – A view looking southward toward the right side crest, upstream embankment and abutment area. The water control structure with primary spillway is seen on the far right edge of the photo.

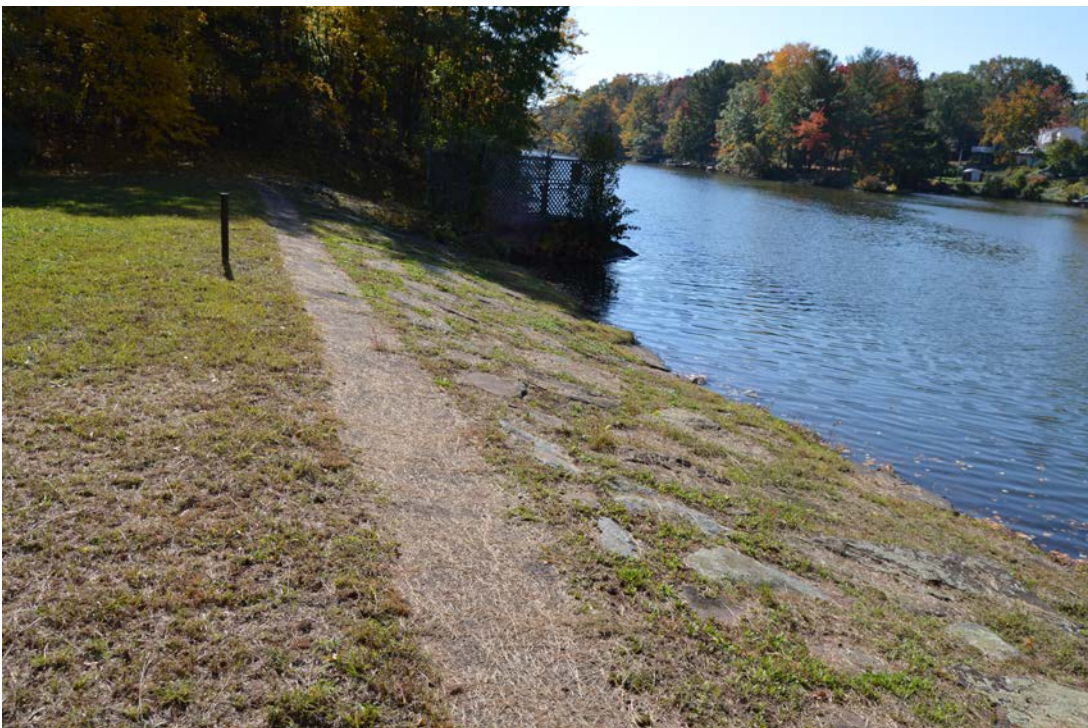
Other: There are 3 piezometers located on the crest of the dam; one on the upstream side and two on the downstream side. The latter two were obscured by brush at the time of the inspection. The visible piezometer is in fair condition, as the exposed section is substantially corroded.

Photo 4a – An overview of the upstream embankment, taken from the left side of the dam. One of the three original piezometers can be seen in the upper left of the photo.

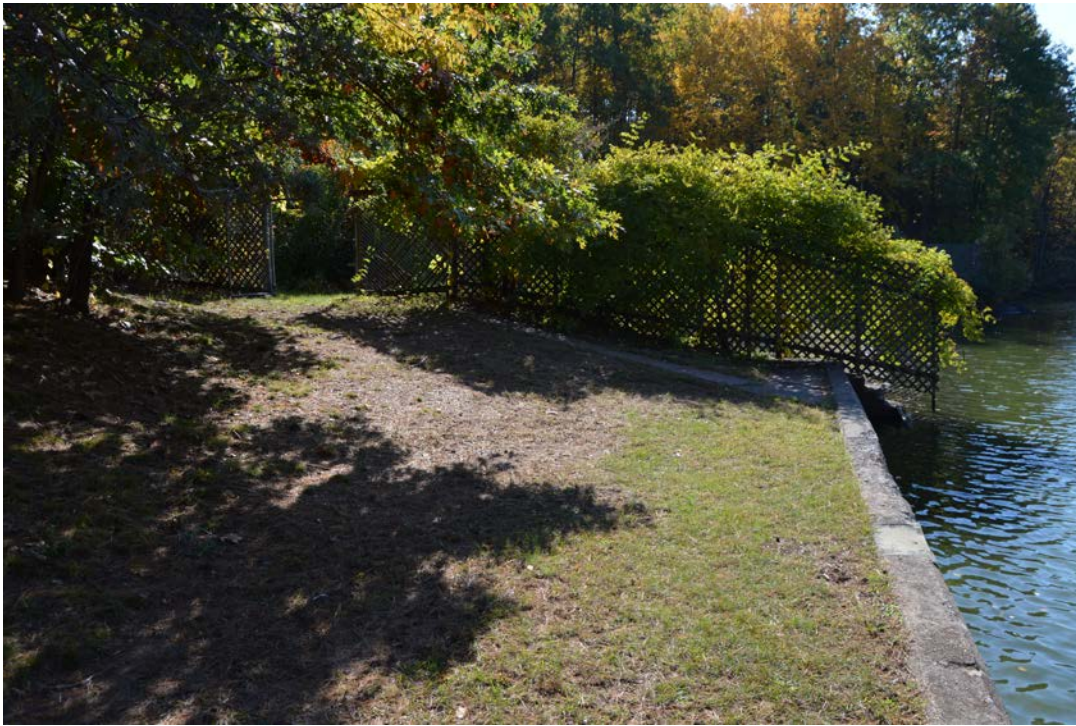
Photo 4b – The left upstream abutment of the dam, located where the chain-link fencing (faced with wooden lattice panels) runs across the embankment. Brush and vines have been allowed to grow unchecked along the fence. The open area in the fence near the center-left of the photo is an access gate. The area in the foreground is the right end of the access way leading to the dam from the Polish Falcons parking lot.

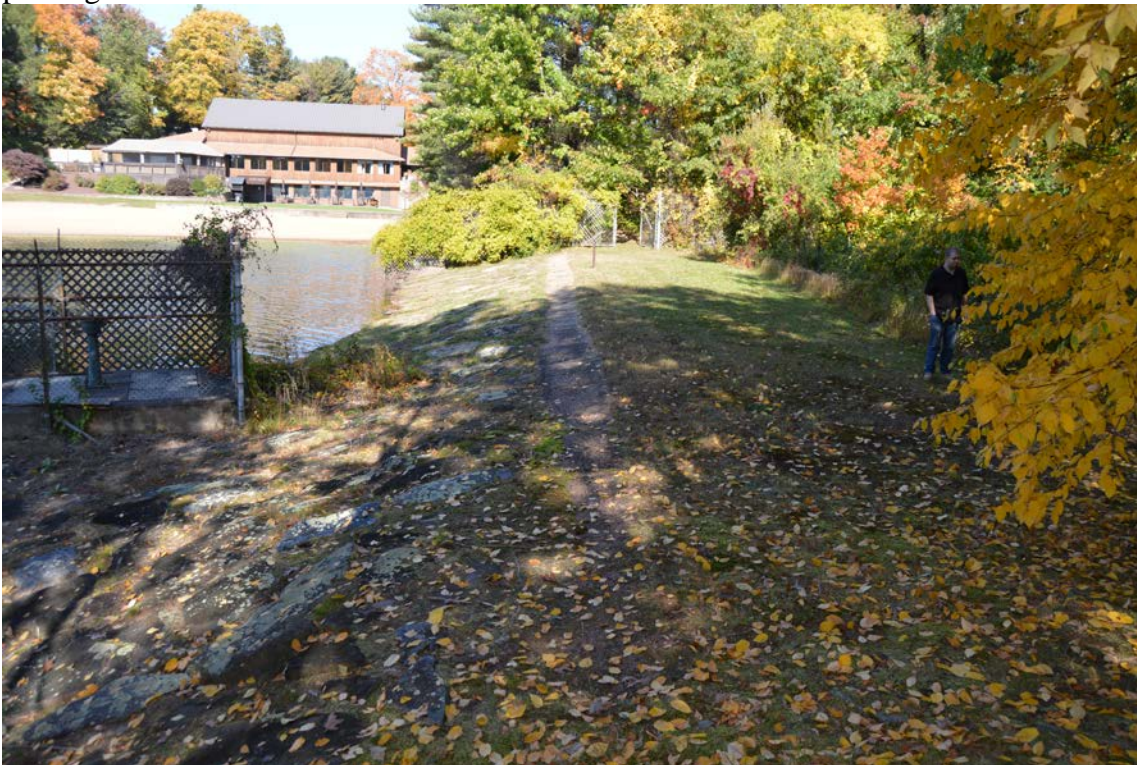
Photo 5 – The crest of the dam as seen from the right abutment area.

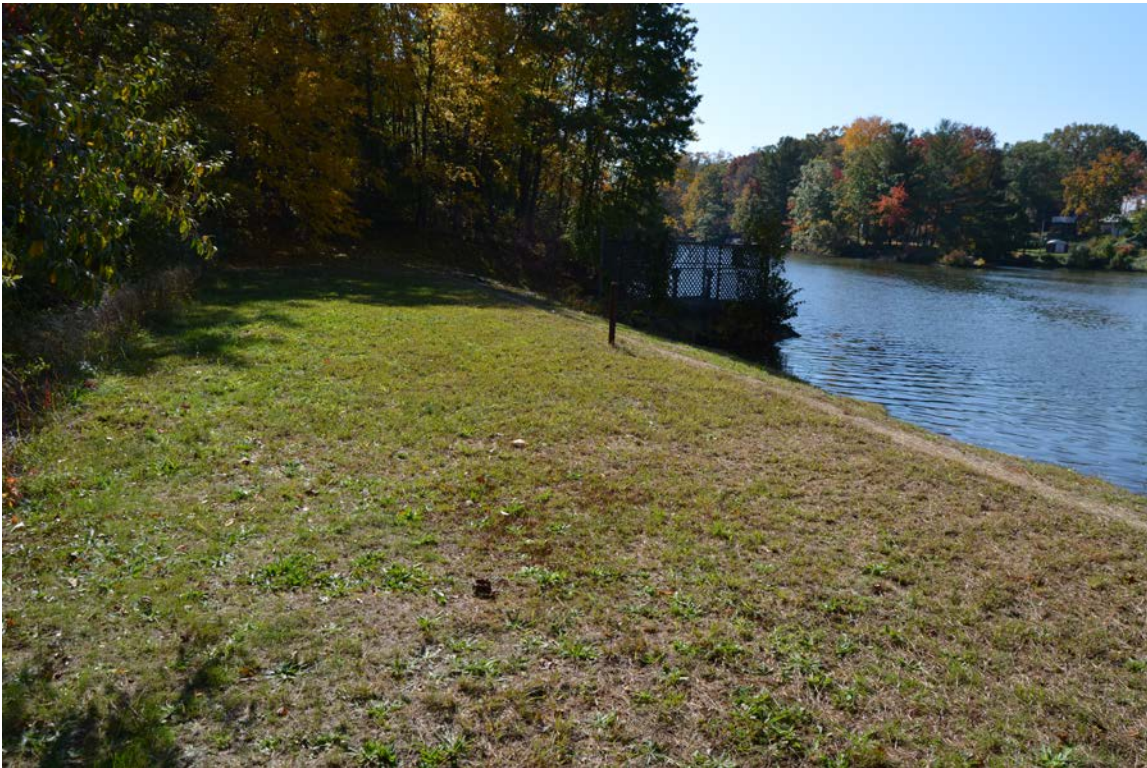
Photo 6 – The crest of the dam as seen from the left side abutment area. A piezometer is again partially visible in the center of the photo.

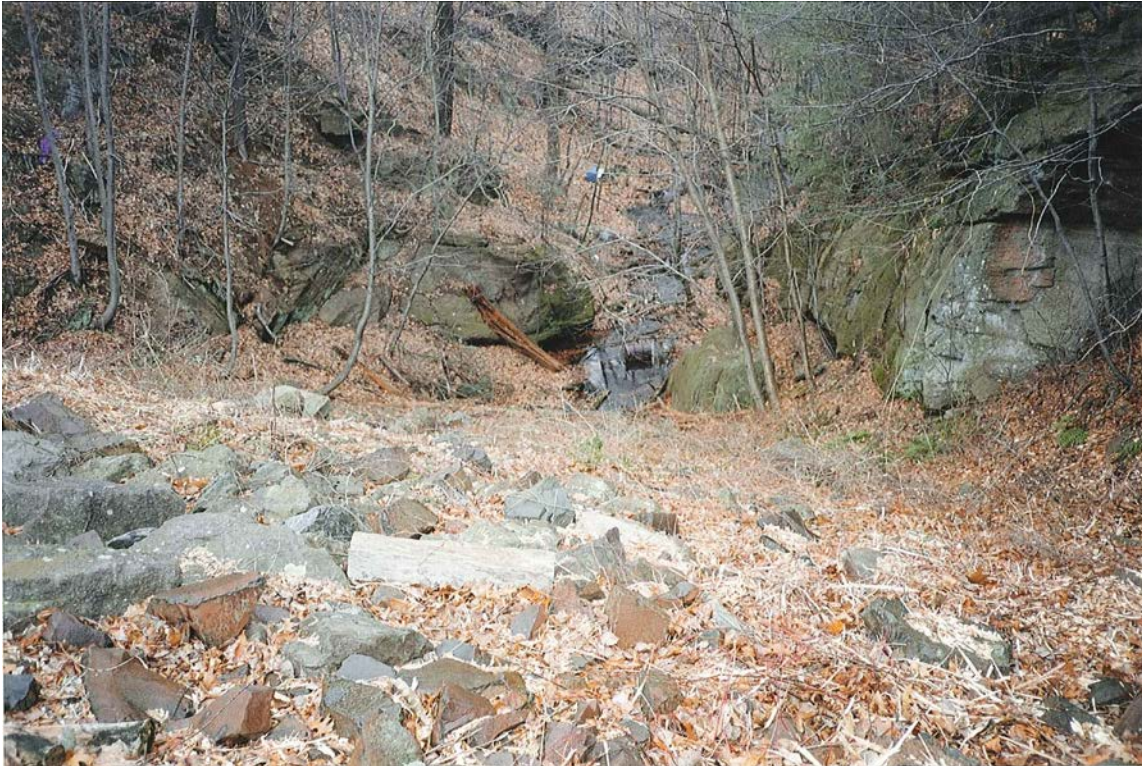
Photo 7b – A view of the downstream embankment from the same right side crest area as in the prior photo (note the bedrock jutting out on the right of the photo for reference). This photo, taken in March 1996, shows the embankment with brush and vegetative growth cleared.

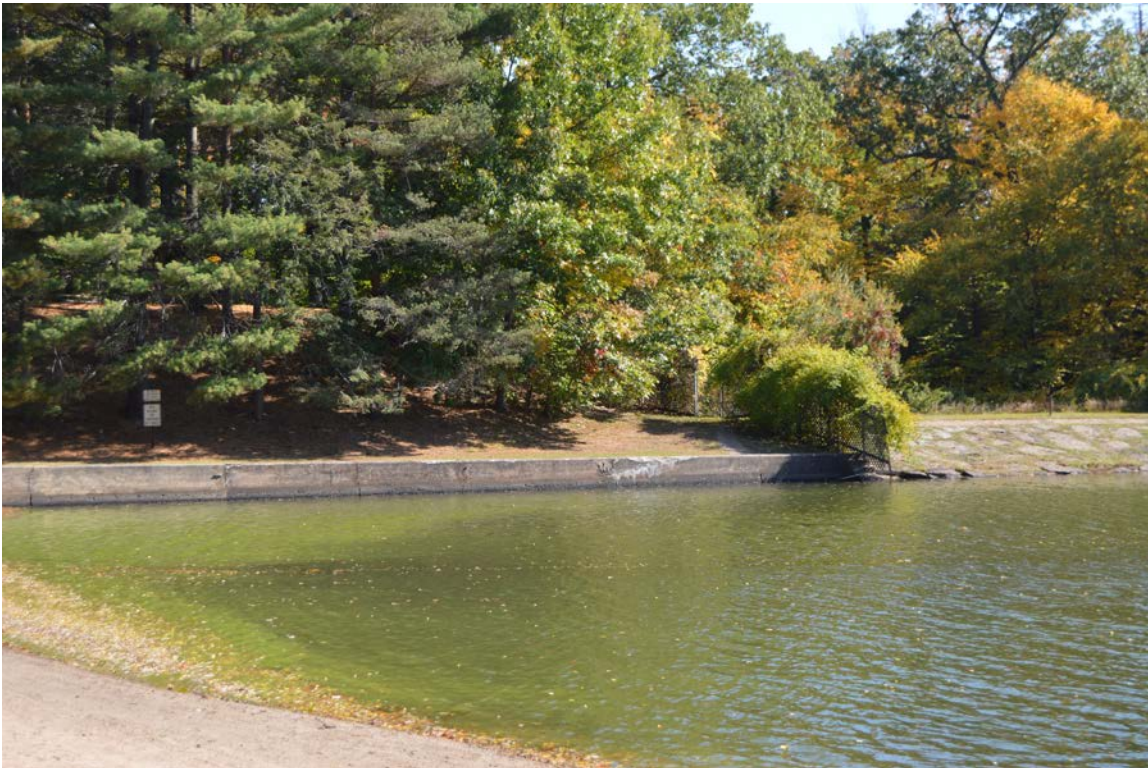
Photo 12 – Looking eastward at the retaining wall running along the access way to the dam from the Polish Falcons parking area and driveway. This wall ends at its junction with the left abutment of the dam.

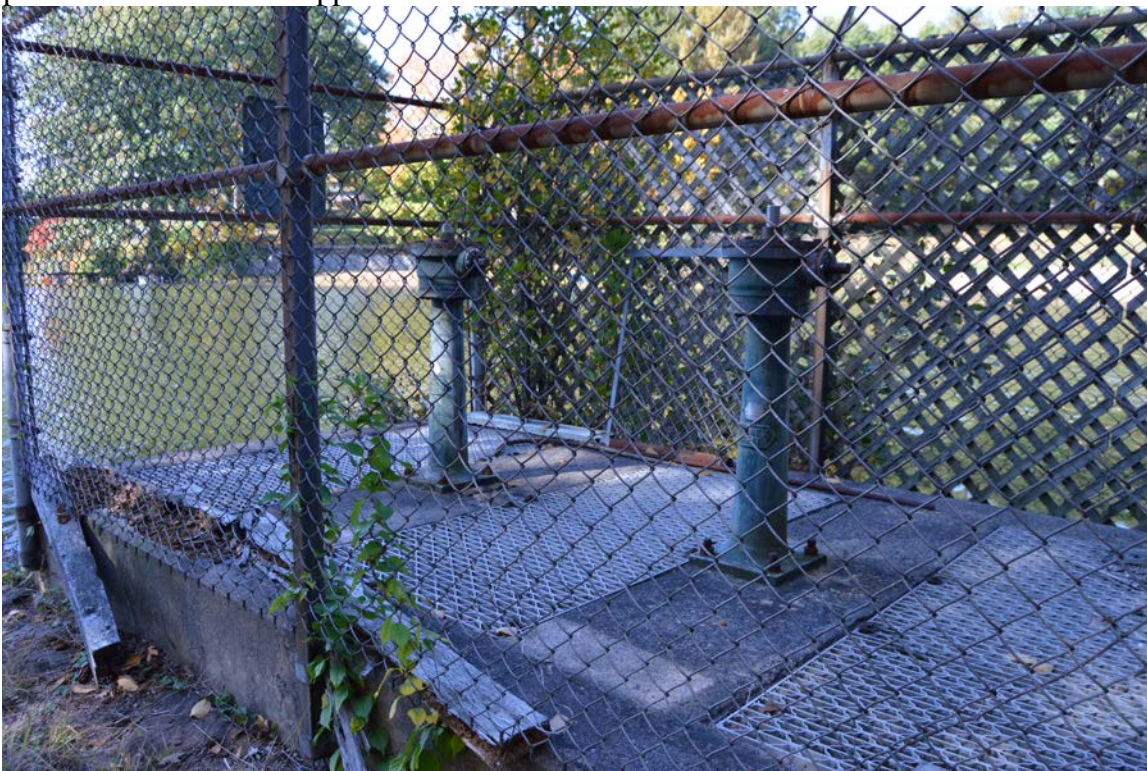
Photo 16b – The top of the water control structure. The openings between the gate operators are covered with locked steel grates.

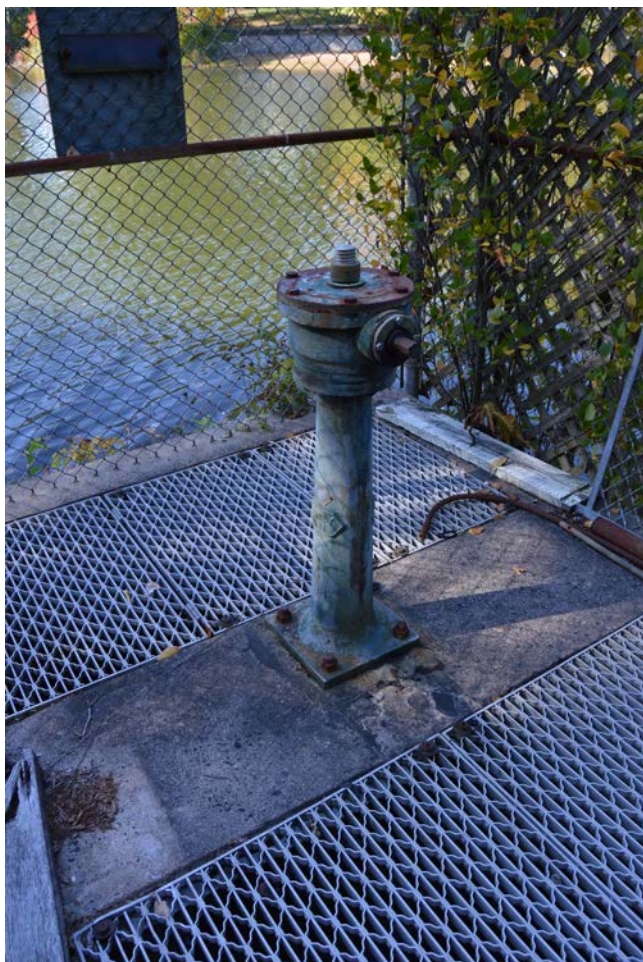
Photo 18b – A close up view of the upstream gate hoisting mechanism.

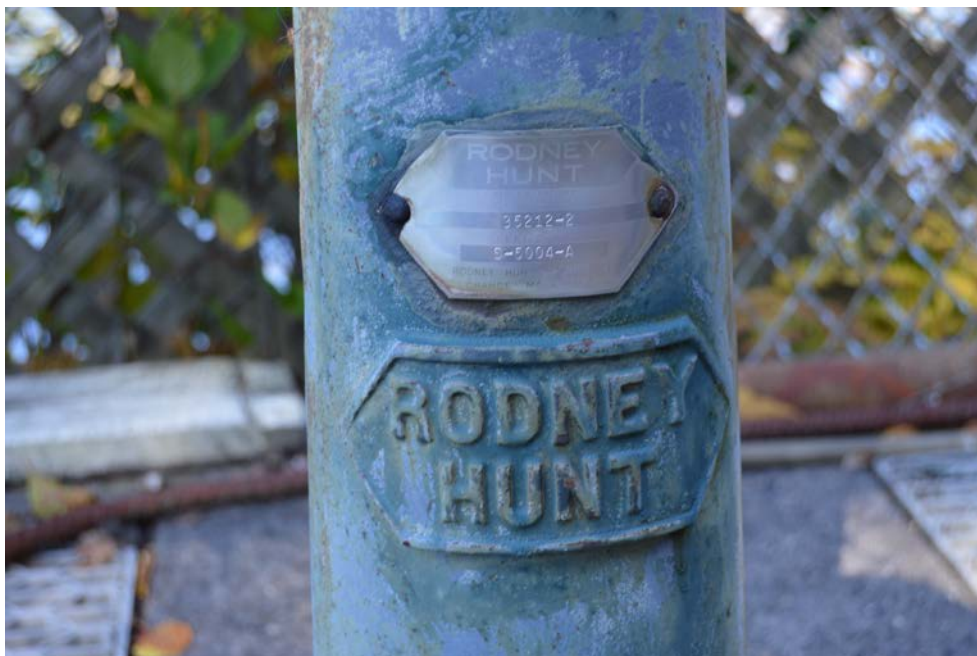
Photo 18c – A photo documenting the gate serial and part numbers. This information is the same for both gate operators.

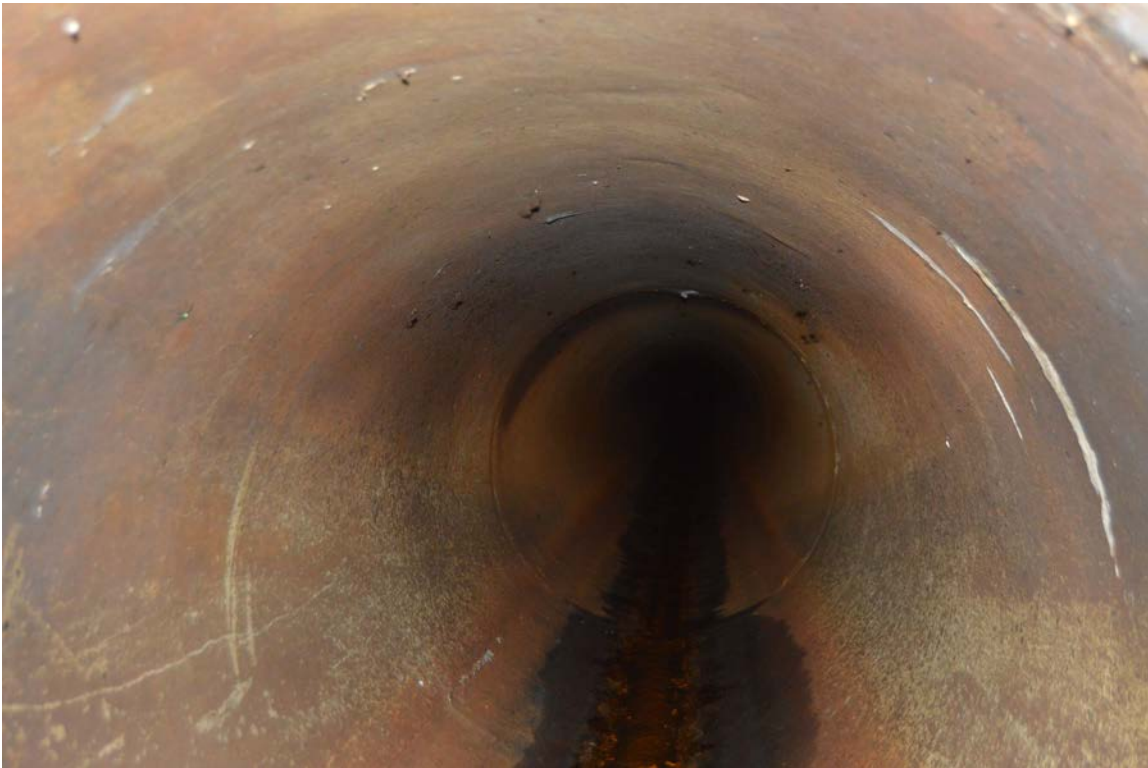
Photo 19c – Looking upstream at the interior of the low level outlet pipe from its discharge end.

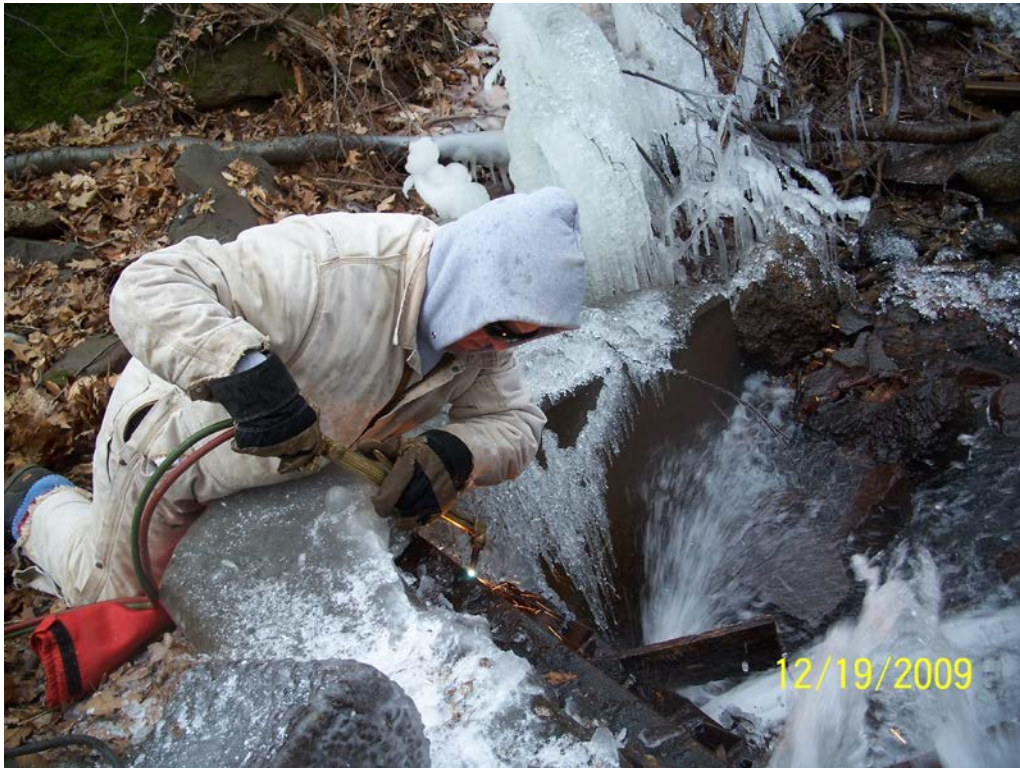
Photo 19e – A photo showing the removal of the trash rack as described in the prior caption. This was accomplished by Jay Kane of Shoreline Diving Services using a cutting torch.

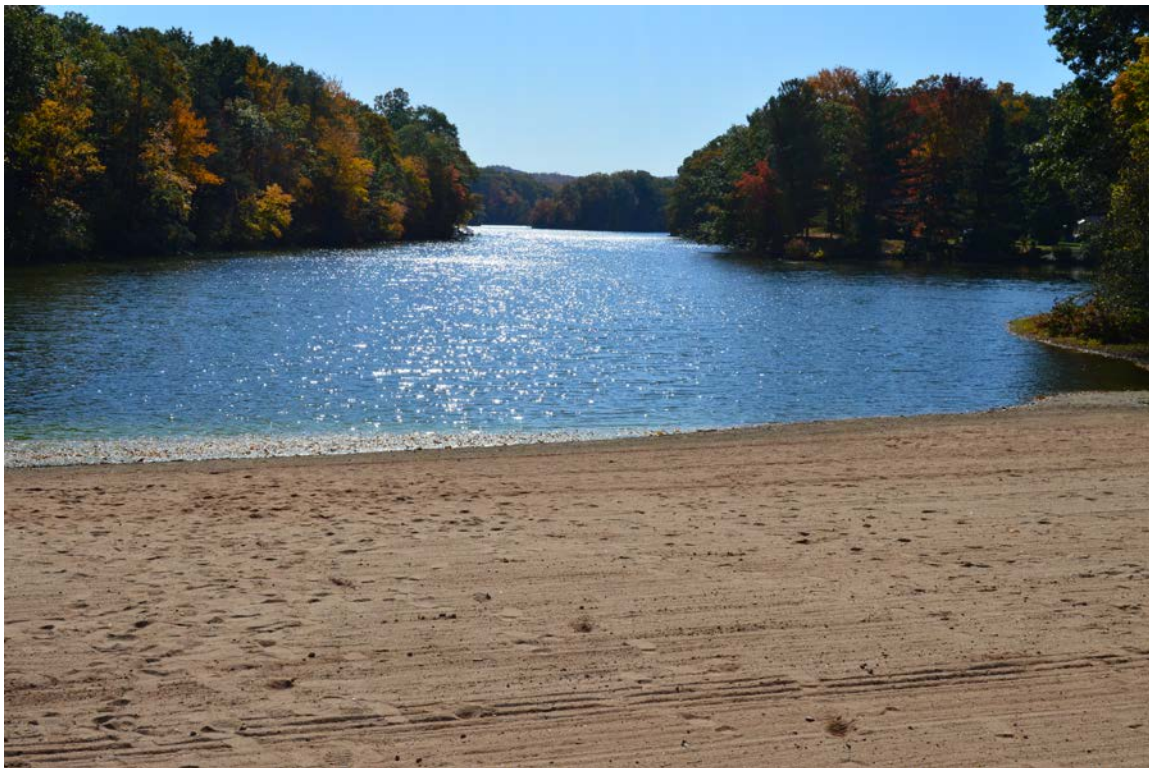
Photo 20 – Crystal Lake as seen from the beach area to the left of the dam.
